AFRL-ML-WP-TP-2006-420

**STRUCTURAL HEALTH
MONITORING OF AN AIRCRAFT
PANEL USING CONTINUOUS AE
SENSOR (PREPRINT)**

Mannur J. Sundaresan, Gangadhararao Grandhi, and Francis Nkrumah

APRIL 2006

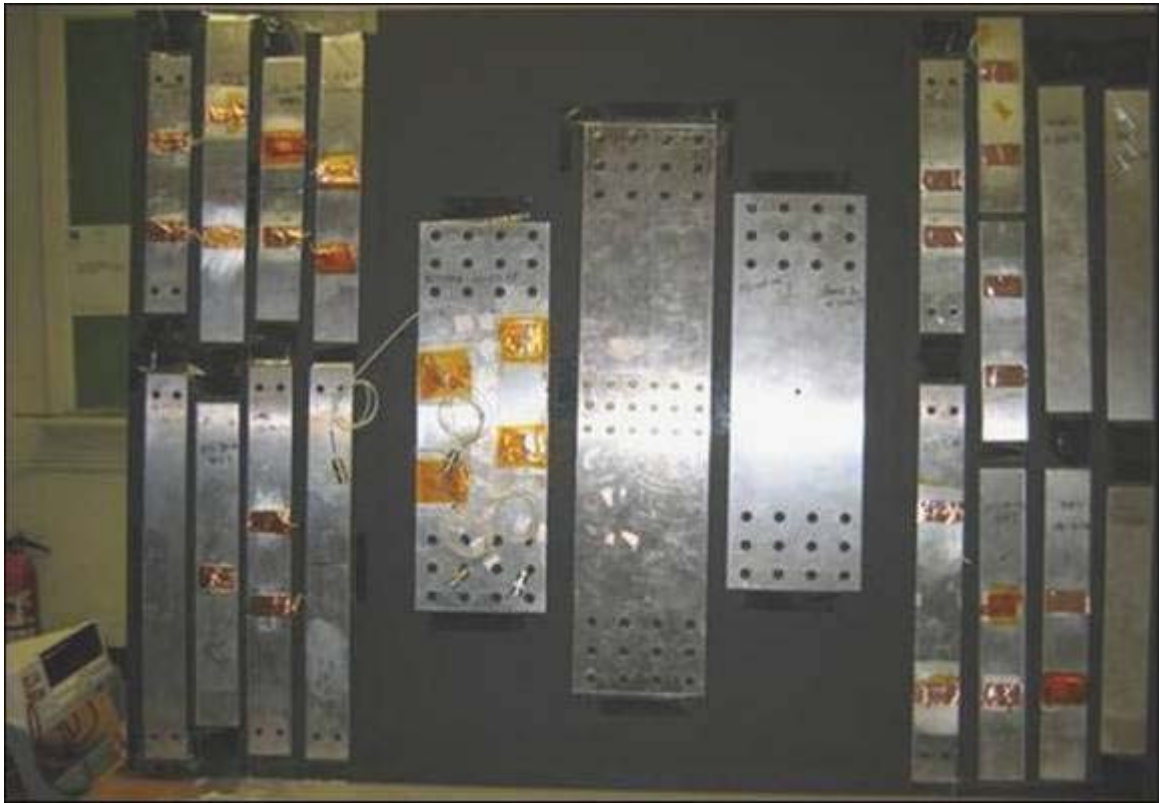
Figure 3. Part of the total number of specimens that were fabricated, precracked, and tested for developing the structural health monitoring technique.
